Manhole Inspection Summary

Manhole # S25I__032MH

Insp Date: **4/1/09 7:31 AM**

Location Address: **100 S. Arlington** Cross Street: **W. Lombard St**

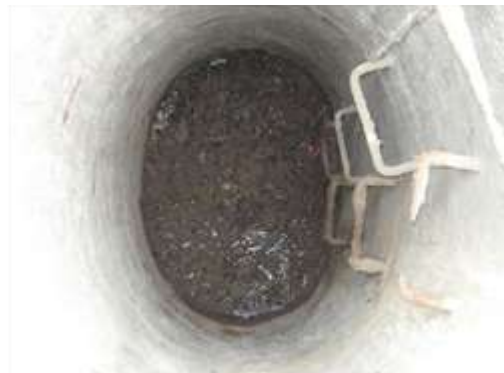
Top View

heavy sediment and debris on base

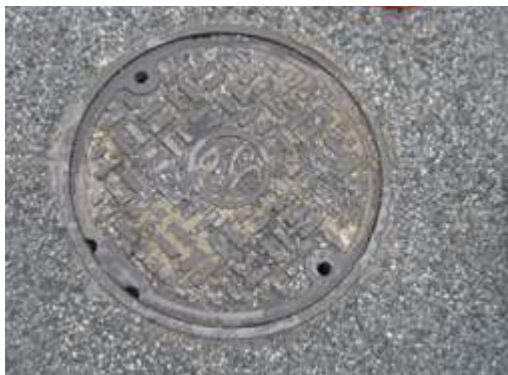
mh cover

Frame Offset: **0** (in.) Condition: ☐ Sound ☐ Cracked ☒ **Leaks**

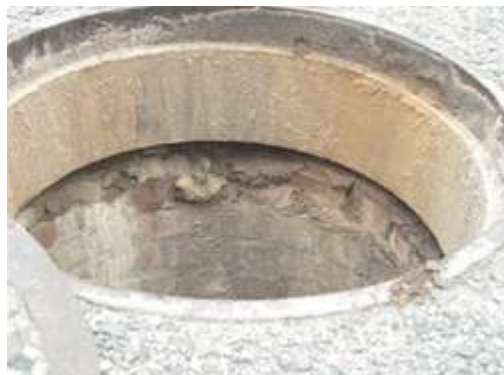
Defect 5

Condition: ☐ Sound ☐ Cracked ☐ Root Intrusion ☐ Loose Brick ☒ **Deteriorated**

Infiltration: ☐ None ☐ Joint ☐ Cracks ☒ **Mortar** ☐ Roots ☐ Wall

deteriorated chimney & infiltration

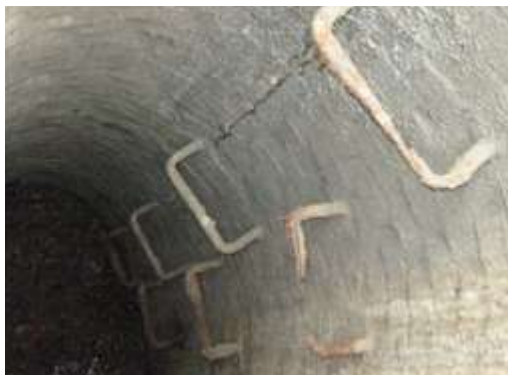
Defect 4

Steps Count: **7** Missing: **1** ☒ **Corroded**

corroded & missing rungs

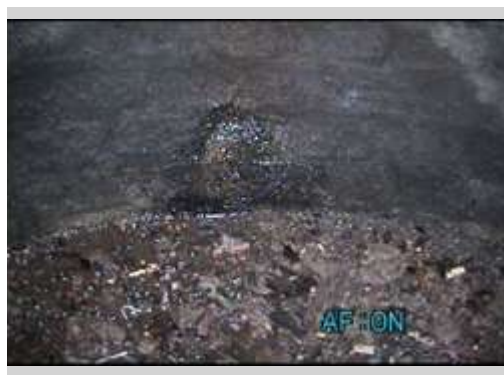
Defect 1

Infiltration: ☐ None ☐ Joint ☐ Cracks ☐ Mortar ☐ Roots ☒ **Wall**

Condition: ☐ Sound ☐ Cracked ☐ Root Intrusion ☐ Deteriorated ☐ Leaks ☒ **Debris**

infiltration in barrel, debris in channel

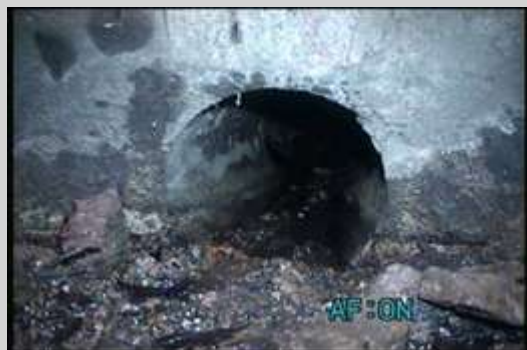
12 O'Clock Outflow

8 in. Circular Gravity Sewer
Pipe Out @ 12 O'Clock
